NASA Technical Memorandum TM 107554

Debris/Ice/TPS Assessment And Integrated Photographic Analysis For Shuttle Mission STS-52

December 1992

Gregory N. Katnik
NASA/Kennedy Space Center

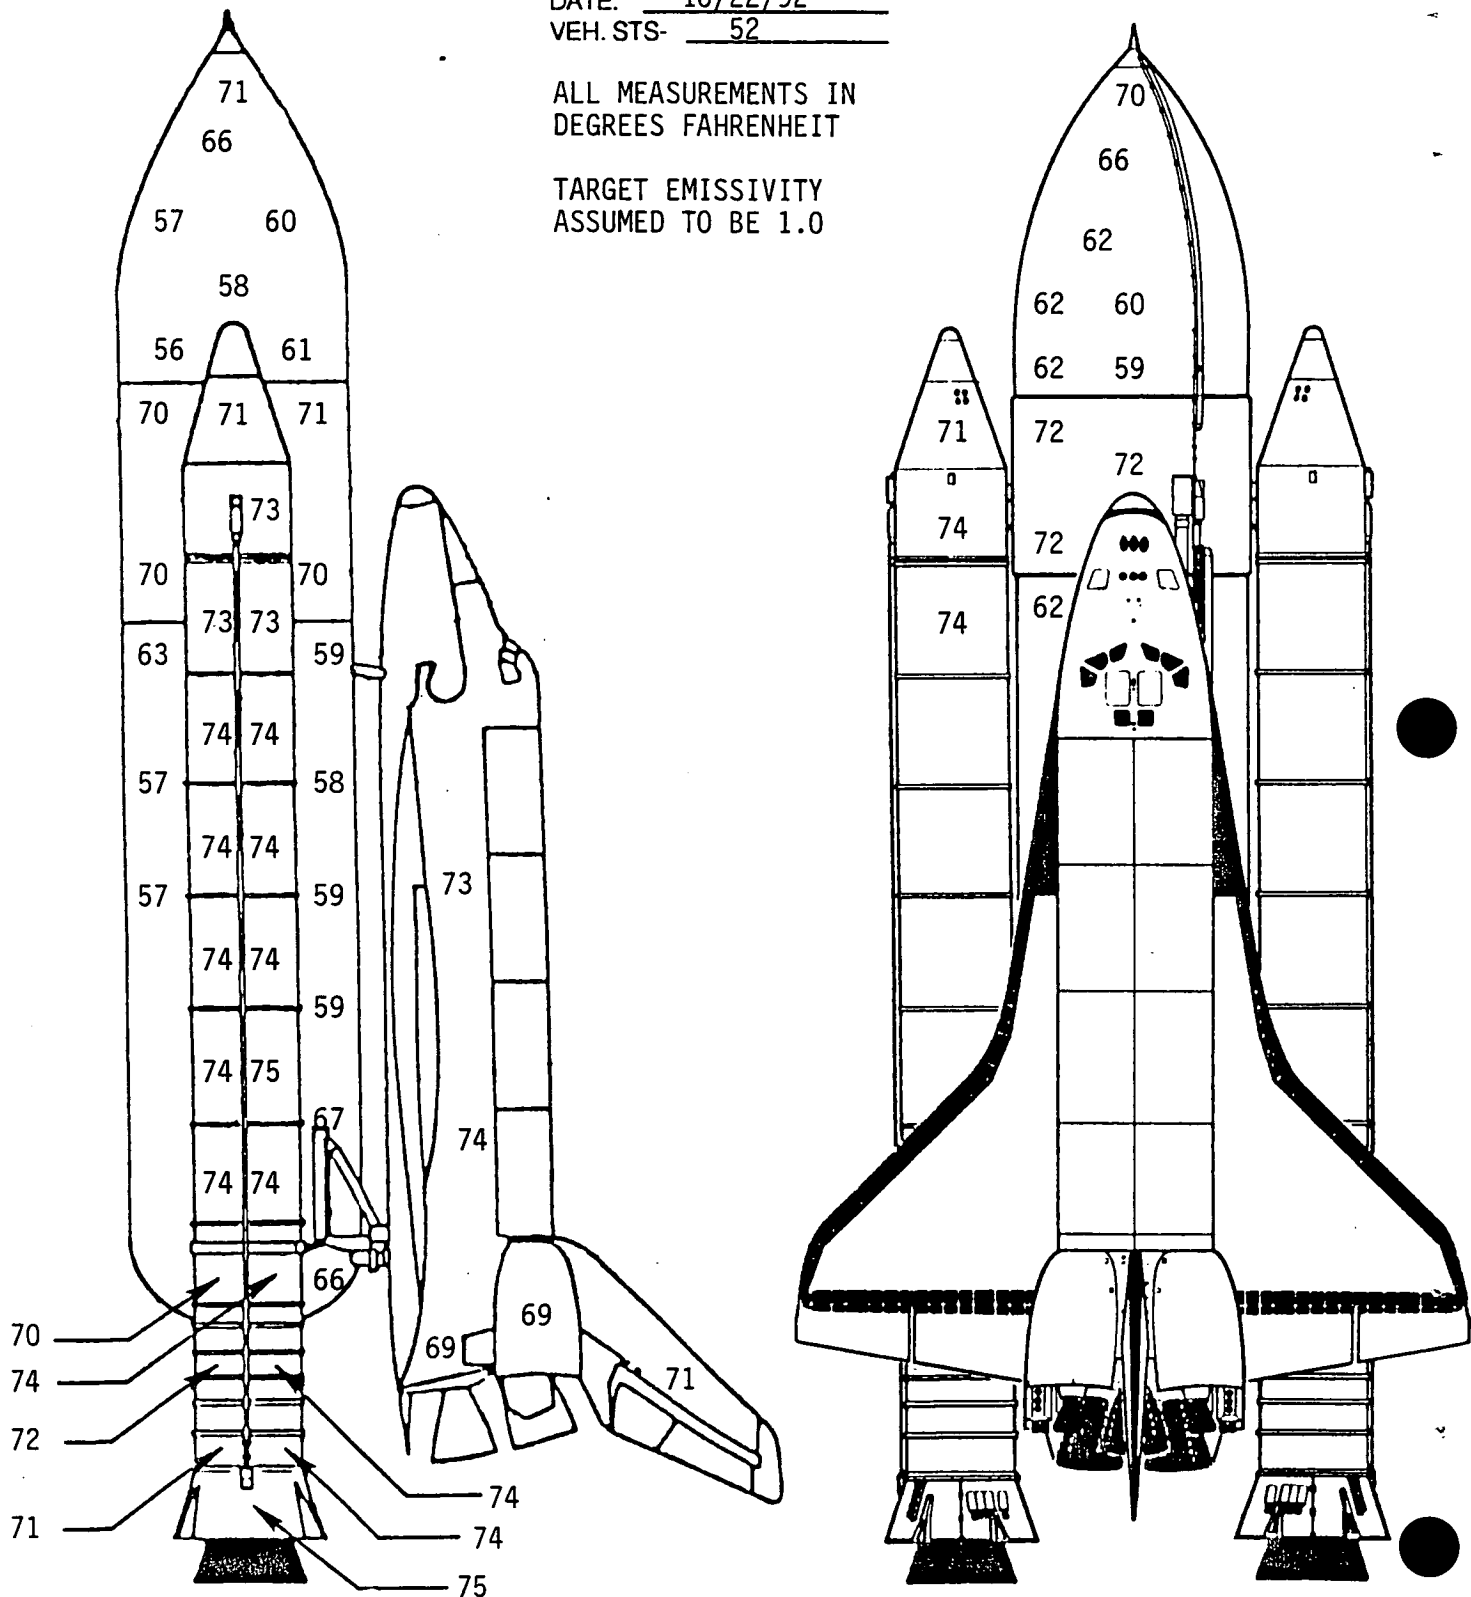
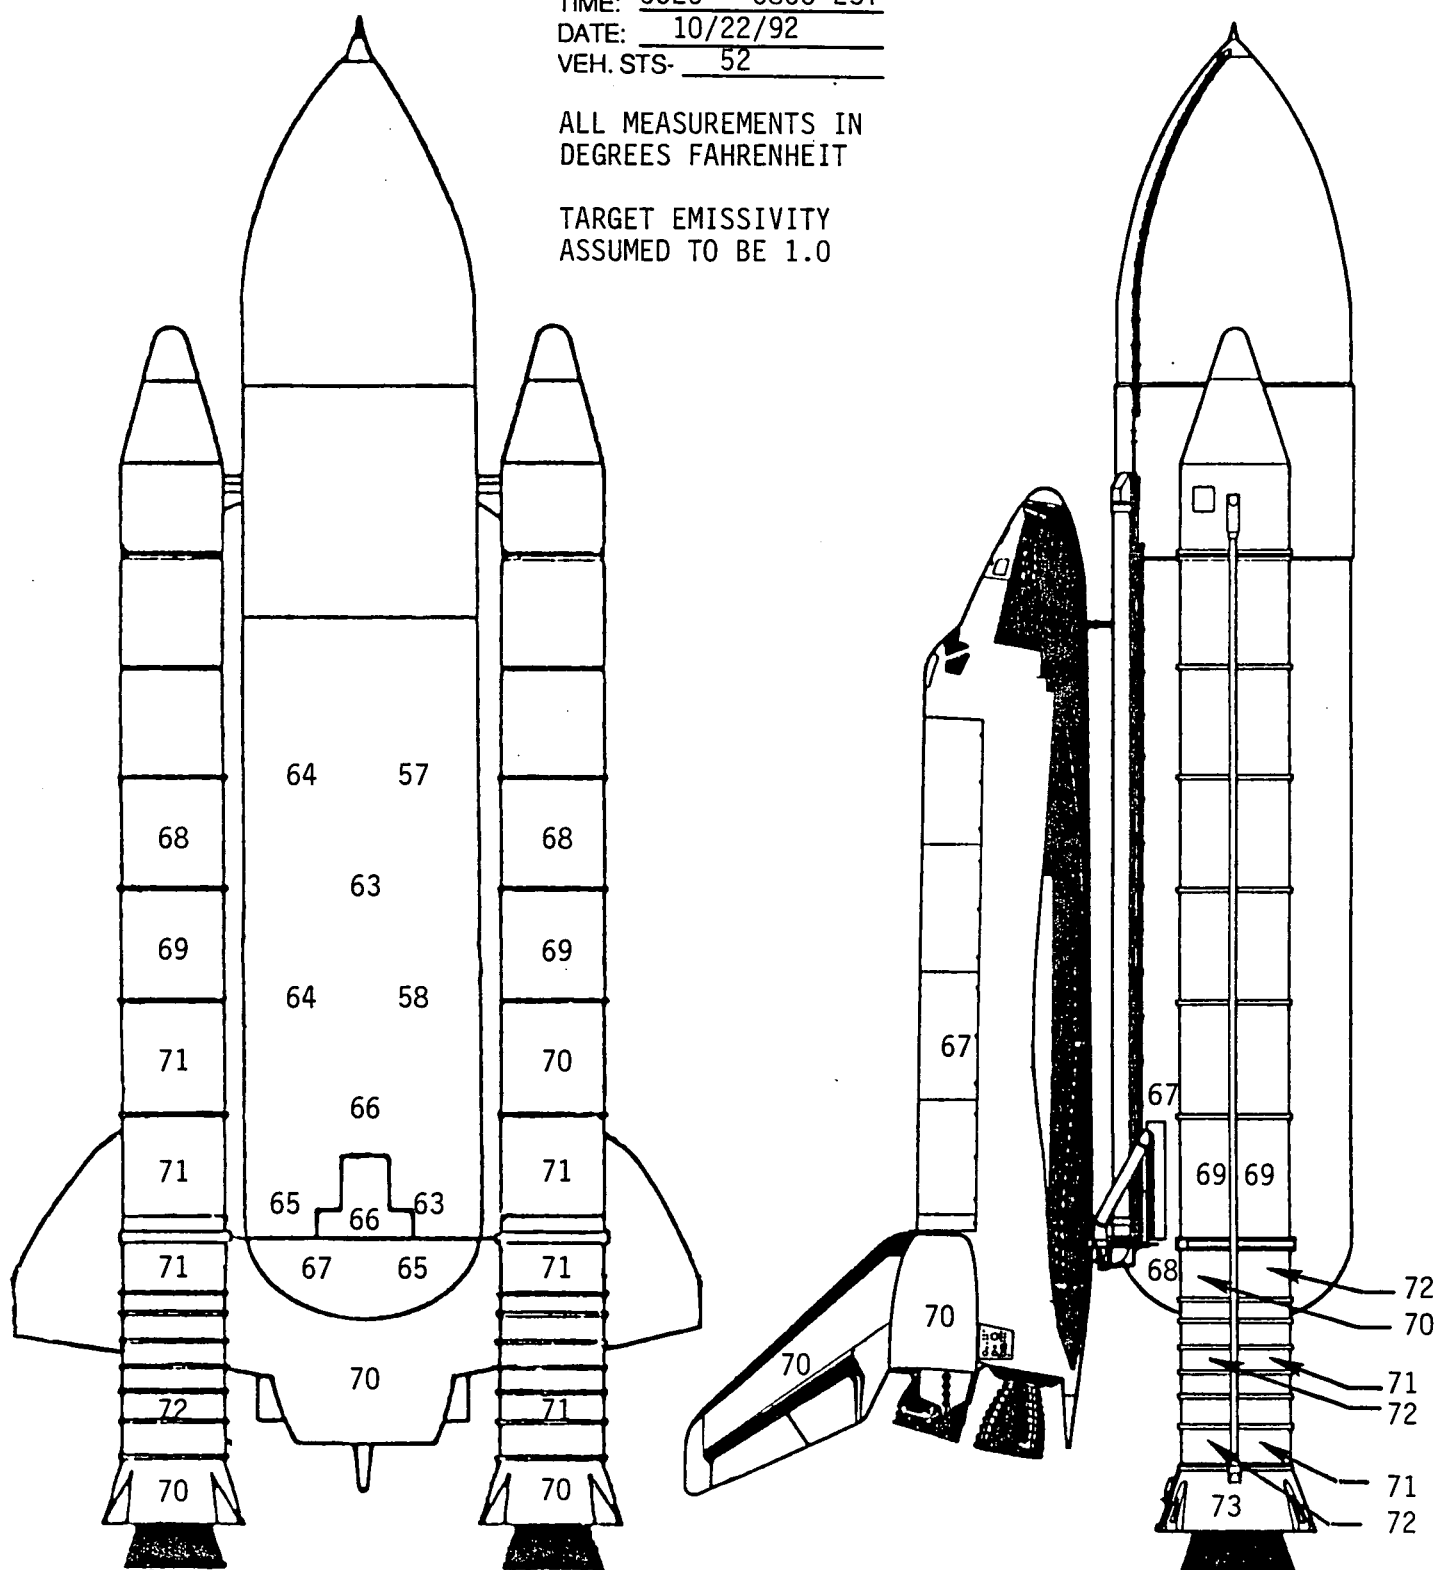
Figure 1. **SSV INFRARED SCANNER
SURFACE TEMPERATURE
SUMMARY DATA**

A portable Shuttle Thermal Imager (STI) infrared scanning radiometer was utilized to obtain vehicle surface temperature measurements for an overall thermal assessment of the vehicle, as shown in Figures 1 and 2.

No SRB anomalies or loose ablator/cork were observed. The K5NA closeouts of the aft booster stiffener ring splice plates were intact. The STI portable infrared scanner recorded RH and LH SRB case temperatures between 68 and 75 degrees Fahrenheit (F). In comparison, temperatures measured by a hand-held Minolta/Land Cyclops spot radiometer ranged from 67 to 75 degrees F and the SRB Ground Environment Instrumentation (GEI) measured temperatures ranging from 72 to 75 degrees F. All measured temperatures were above the 34 degrees F minimum requirement. The predicted Propellant Mean Bulk Temperature (PMBT) supplied by MTI was 78 degrees F, which was within the required range of 44-86 degrees F.

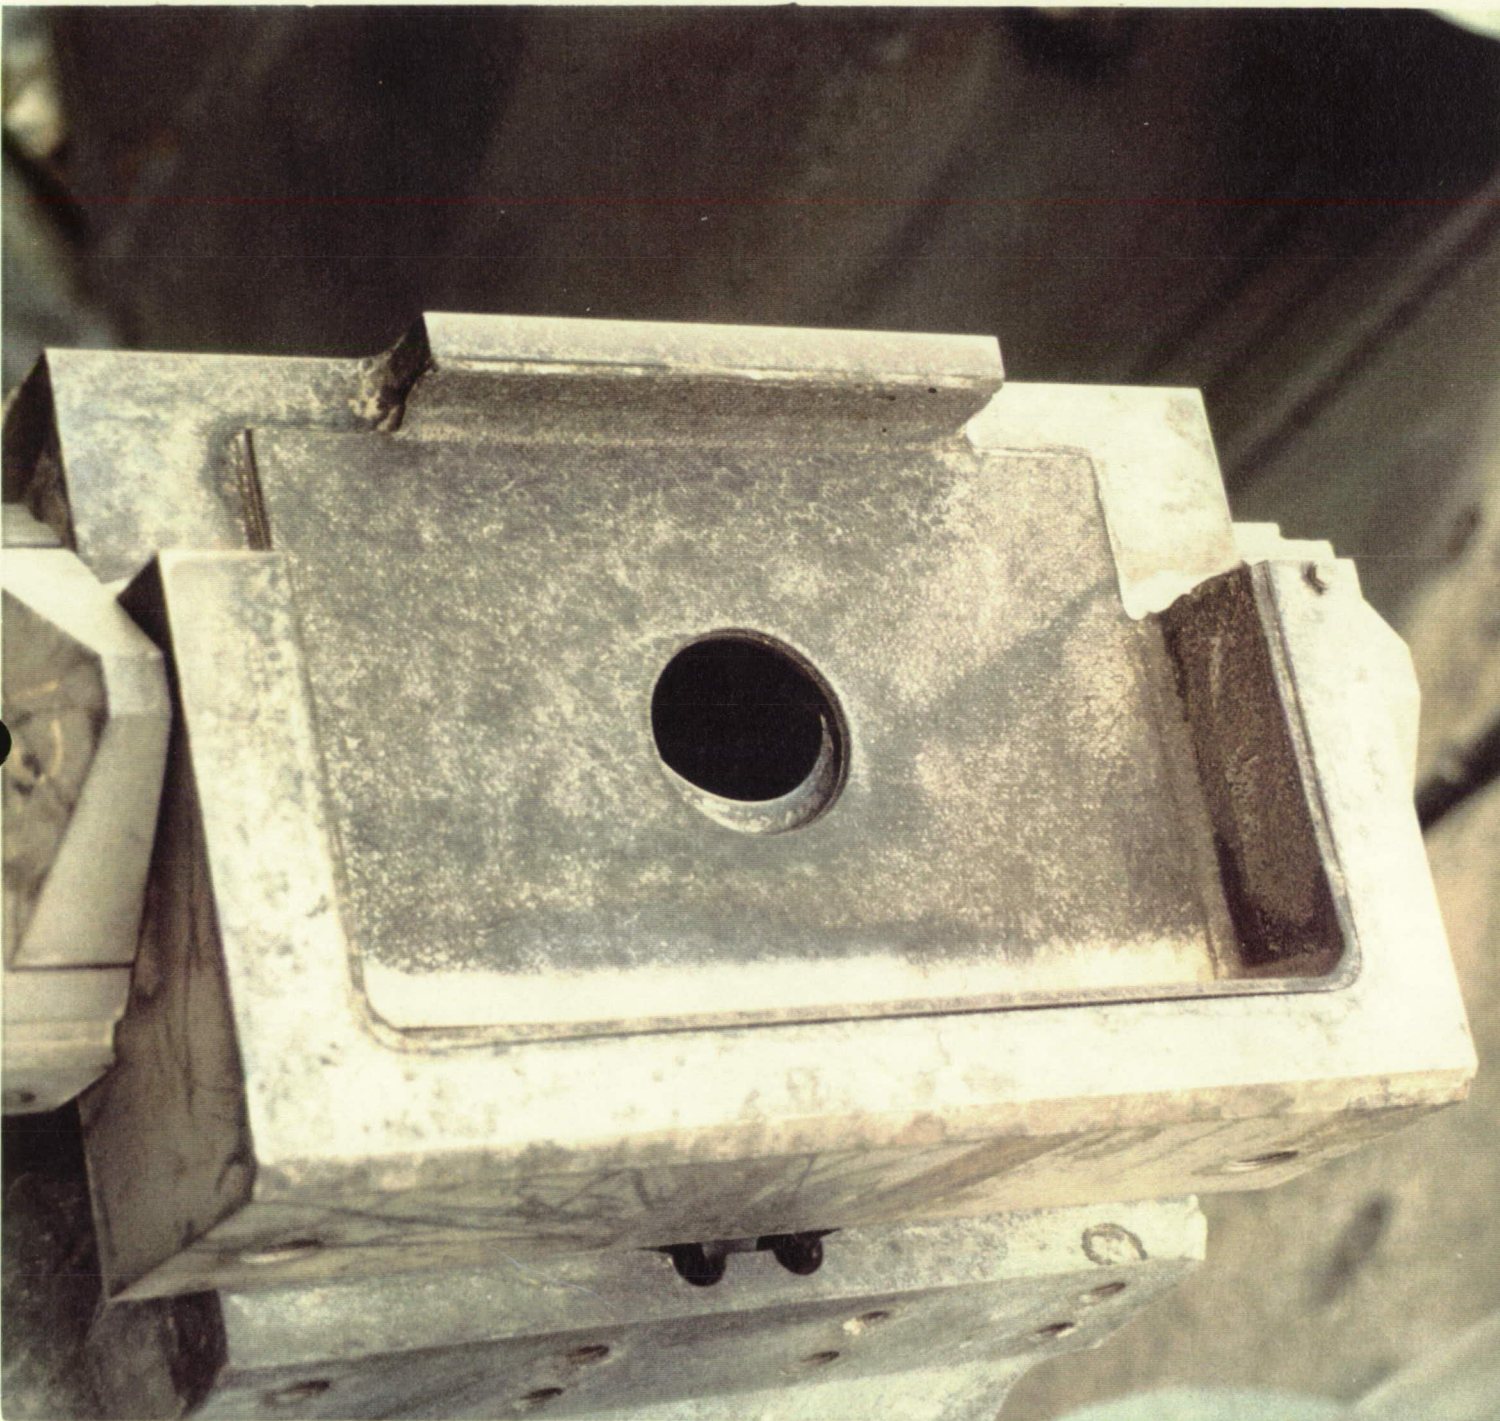
Plume erosion of the south SRB holddown posts was typical. EPON shim material was intact but slightly debonded from the holddown post shoes.

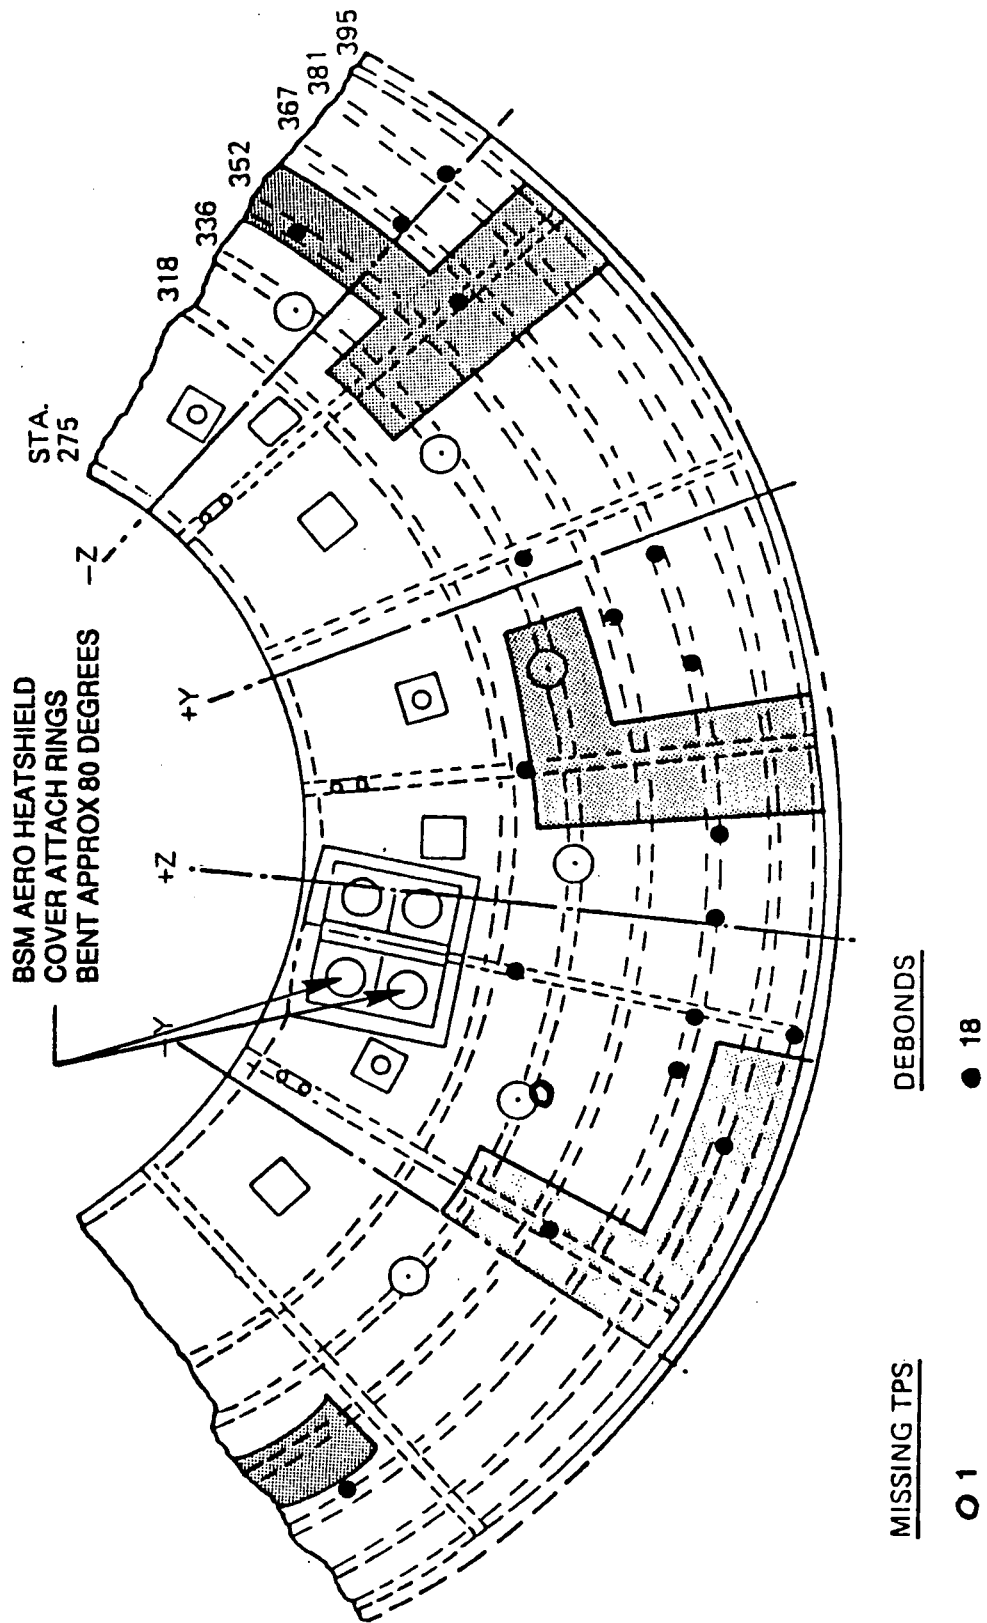
Figure 4. **RIGHT SRB FRUSTUM**

The RH frustum had 18 MSA-2 debonds over fasteners and one 1.5" diameter area of missing TPS in the -Y+Z quadrant at the 336 ring frame. Minor localized blistering of the Hypalon paint had occurred predominantly along the 395 ring (Figure 4). All BSM aero heat shield covers were locked in the fully opened position though the left two cover attach rings had been bent by parachute riser entanglement.

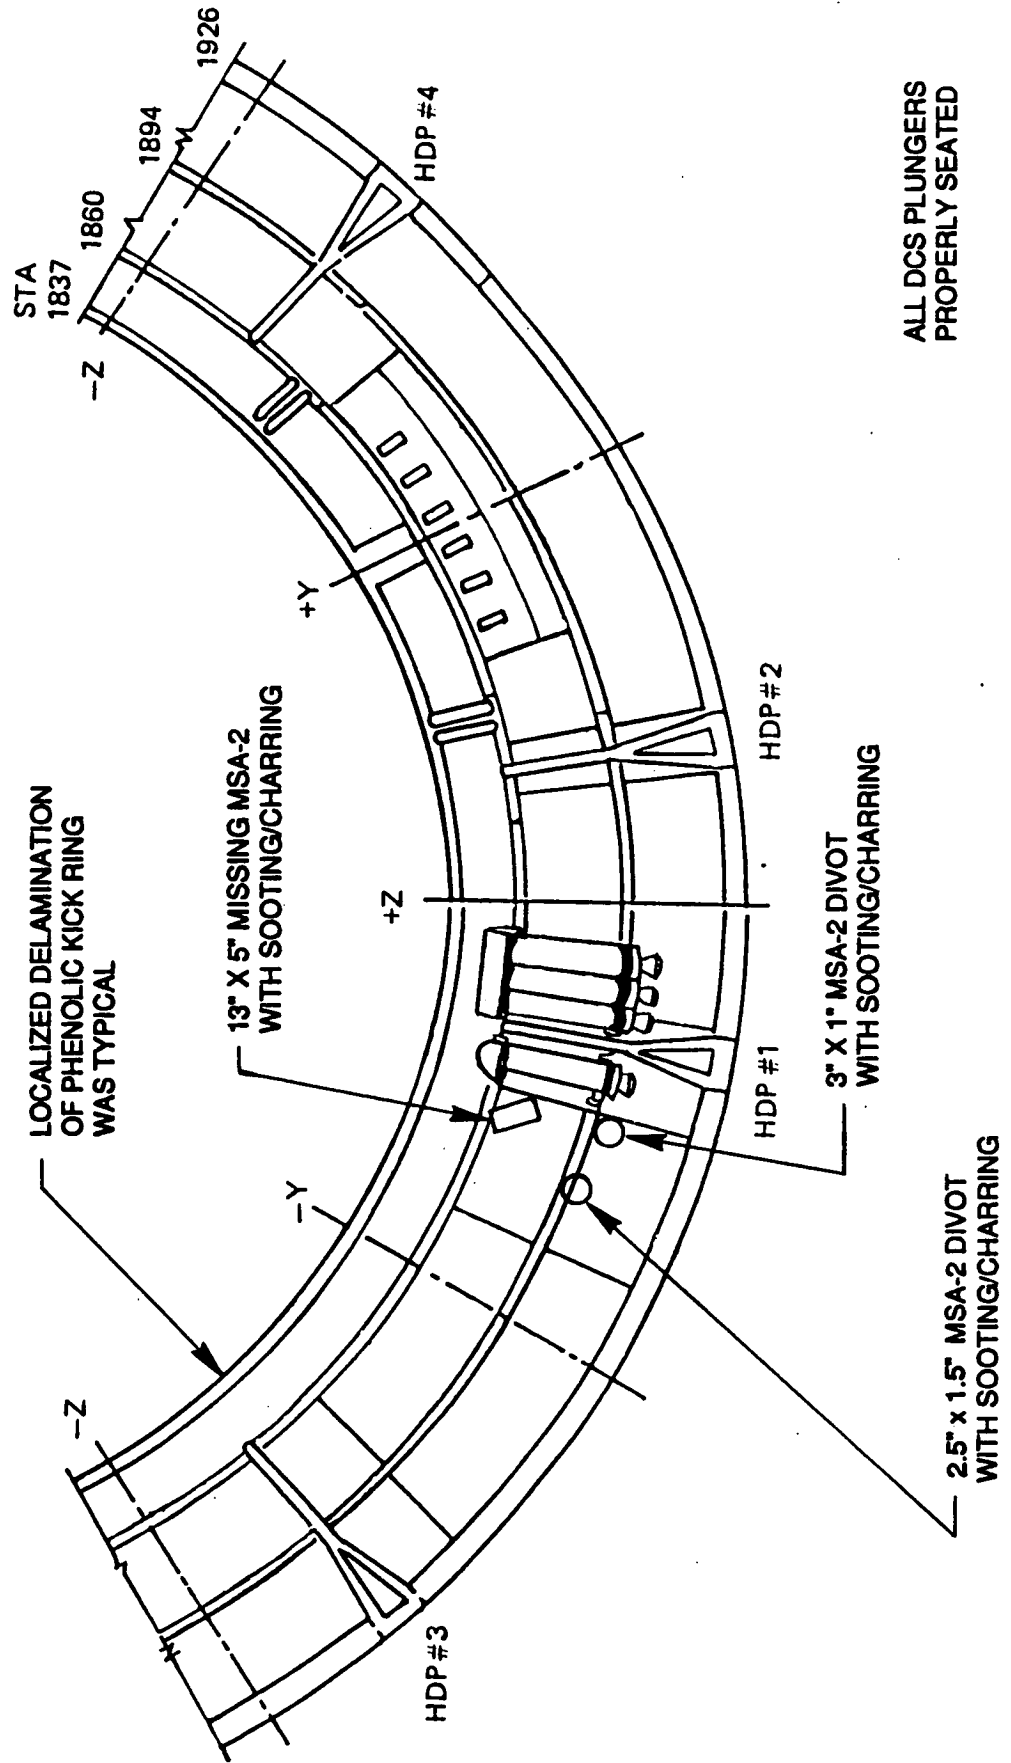
Figure 6. **RIGHT SRB AFT SKIRT EXTERIOR TPS**

The phenolic material on the kick ring was delaminated. Two divots, measuring 13" x 5" and 3" x 1", had occurred on the aft skirt acreage TPS just to the -Y side of the single BSM. Some of the material along the aft edge of the divots appeared sooted/charred. A third divot, measuring 2.5" x 1.5", had occurred between the single BSM and the -Y axis at station XB-1894 partially exposing two fastener head covers (Figure 6). Samples were taken from all three locations for laboratory analysis. K5NA was missing from all BSM nozzles.

Approximately 50 percent of the EPON shim was missing from HDP #3 aft skirt foot. The substrate was sooted/charred indicating that the shim material was lost prior to water impact. All Debris Containment System (DCS) plungers were seated properly. This was the eleventh flight utilizing the optimized link.

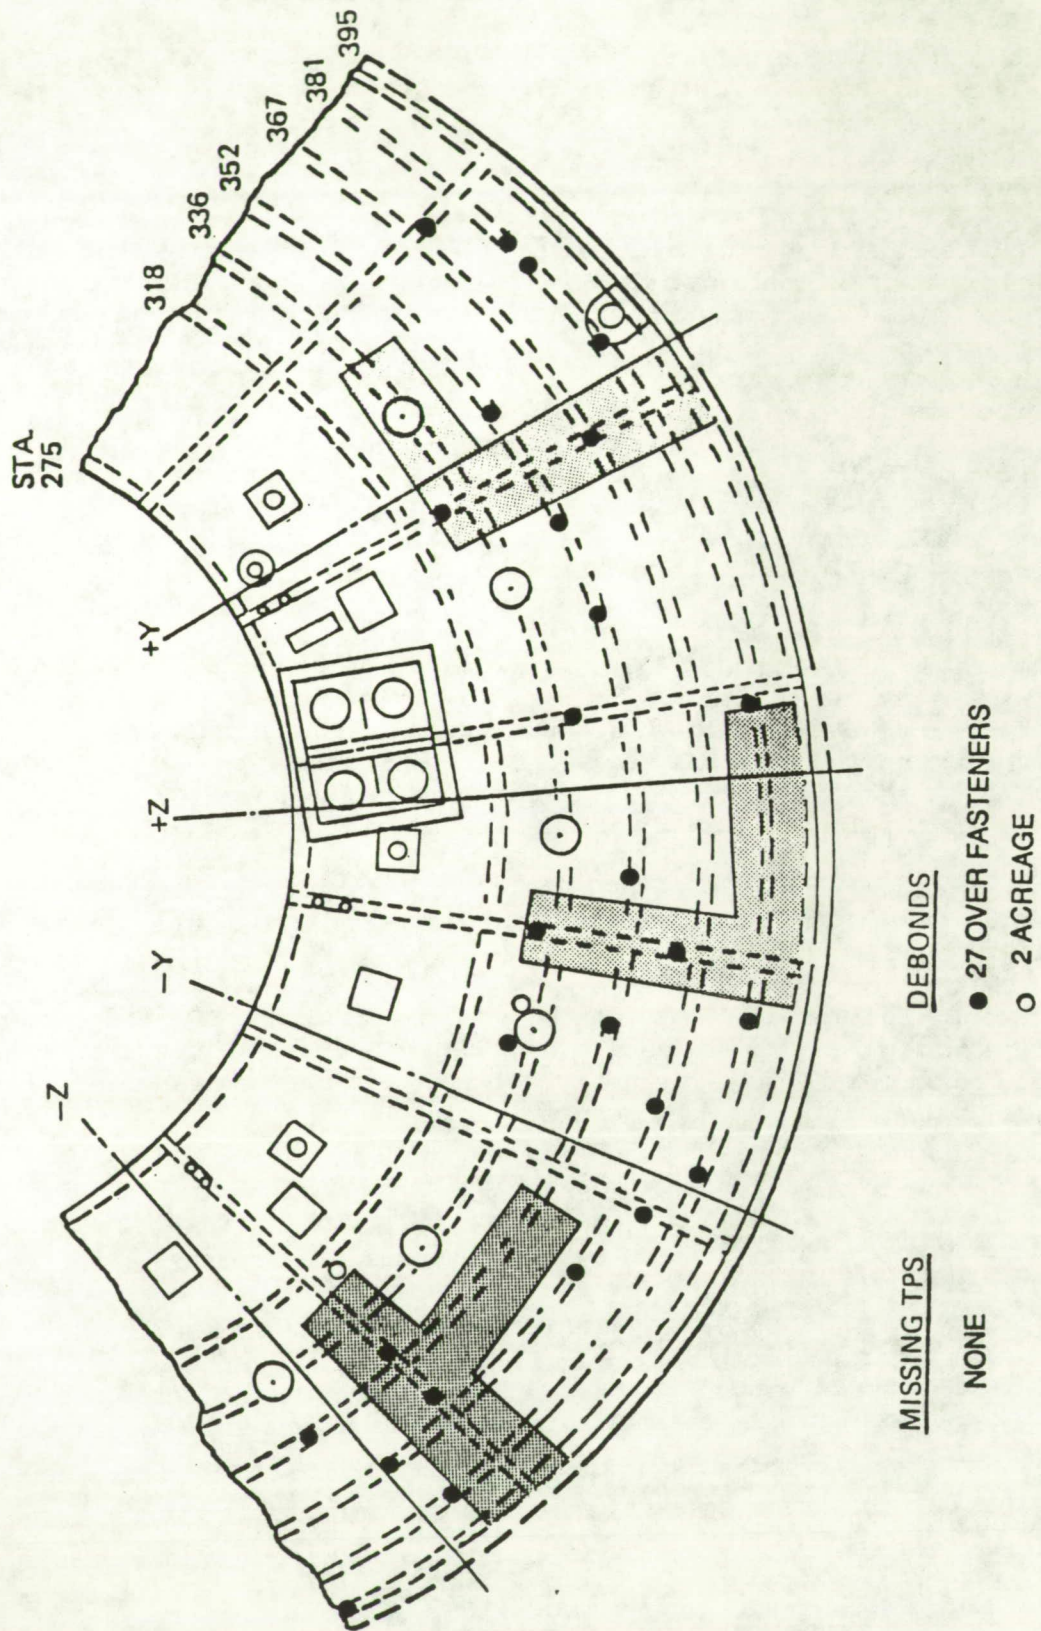
Figure 7. LEFT SRB FRUSTUM

The LH frustum was missing no TPS, but had 27 MSA-2 debonds over fasteners and two MSA-2 acreage debonds. There was minor localized blistering of the Hypalon paint along the 395 ring frame (Figure 7). The BSM aero heatshield covers were locked in the fully opened position.

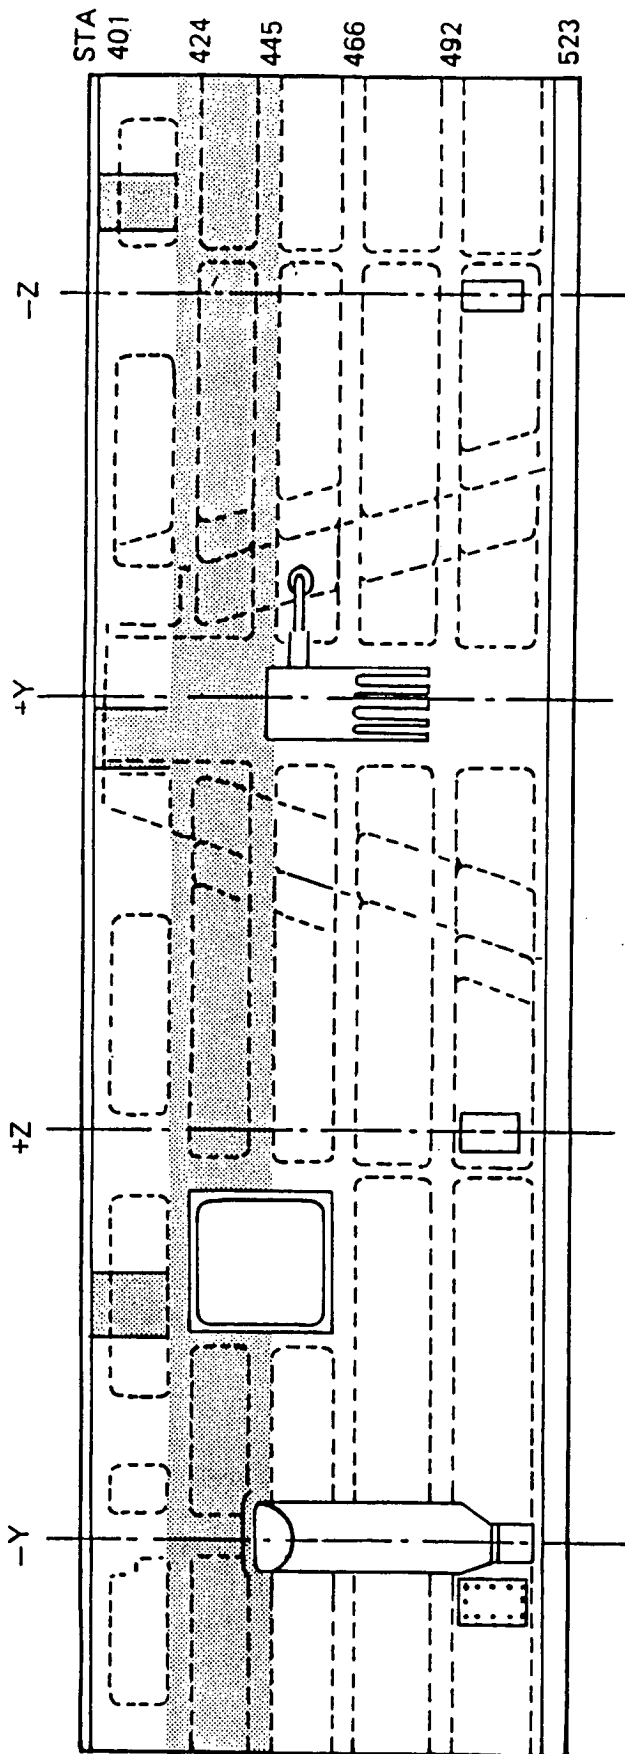
Figure 8. **LEFT SRB FWD SKIRT**

The LH forward skirt exhibited no debonds or missing TPS. The phenolic plates on both RSS antennae were intact and undamaged (Figure 8). The forward separation bolt and electrical cables appeared to have separated cleanly. No pins were missing from the frustum severance ring. Minor blistering of the Hypalon paint occurred near the ET/SRB attach point.

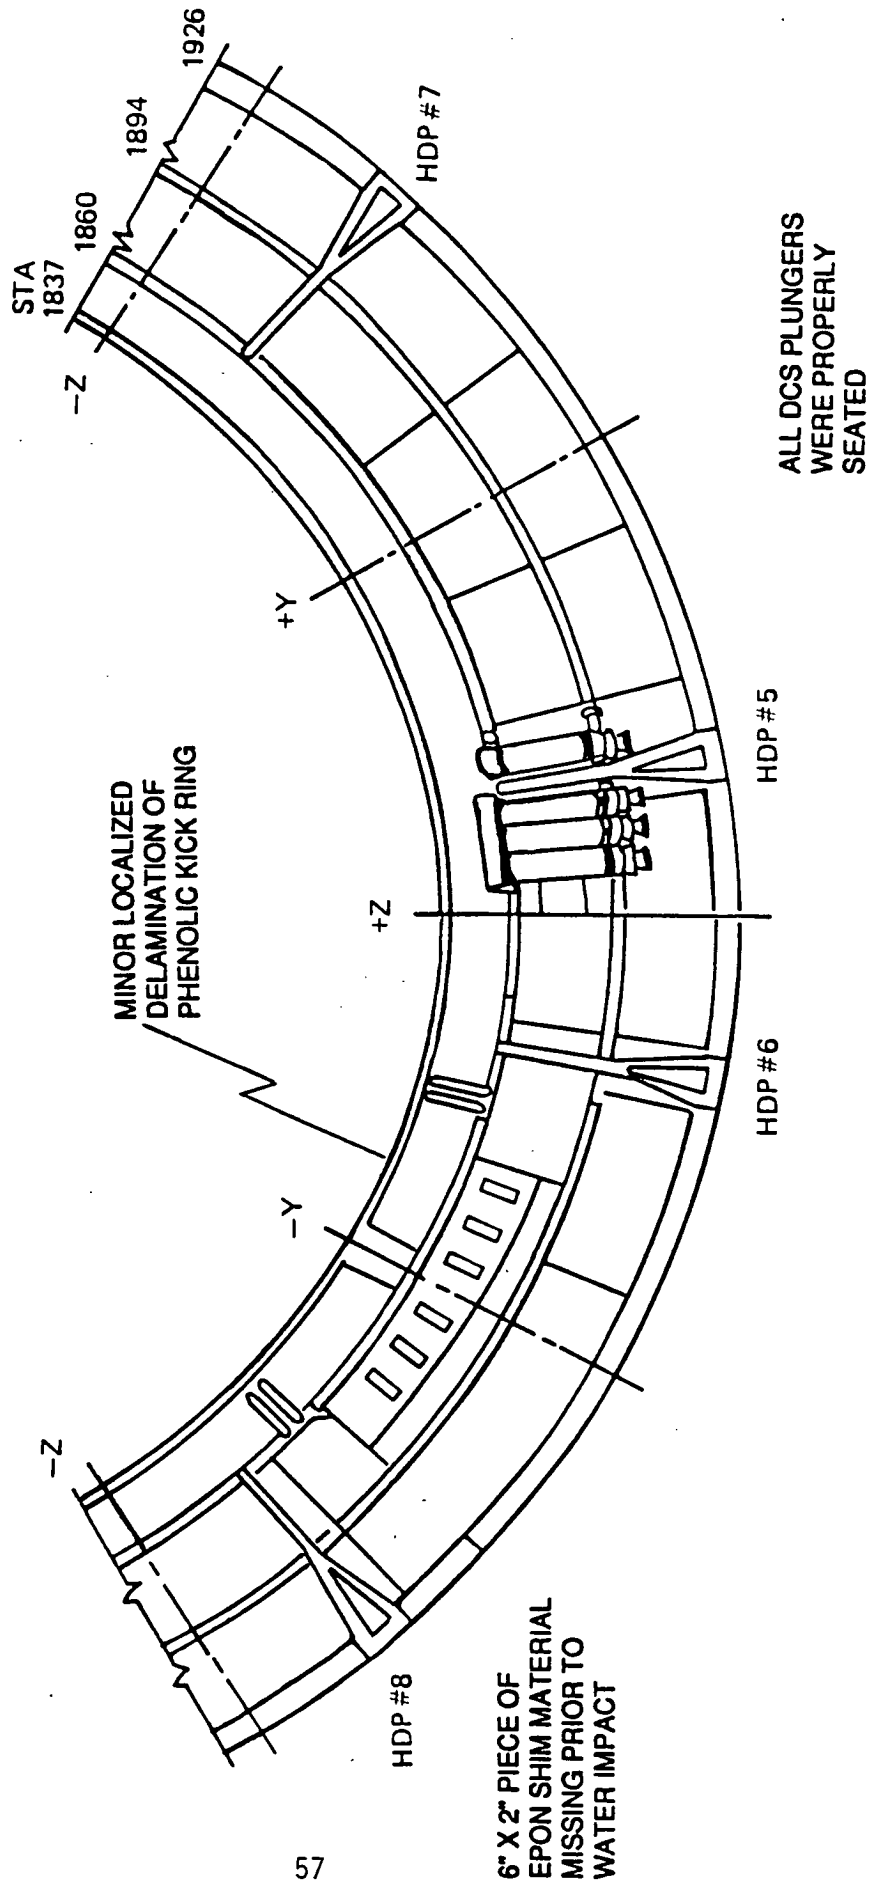
Figure 9. LEFT SRB AFT SKIRT EXTERIOR TPS

The phenolic material on the kick ring exhibited localized delamination. The acreage TPS on the aft skirt was generally in good condition (Figure 9).

A 6" x 2" piece of EPON shim was lost from HDP #8 aft skirt foot prior to water impact. All four Debris Containment System (DCS) plungers were properly seated. This was the eleventh flight utilizing the optimized link.

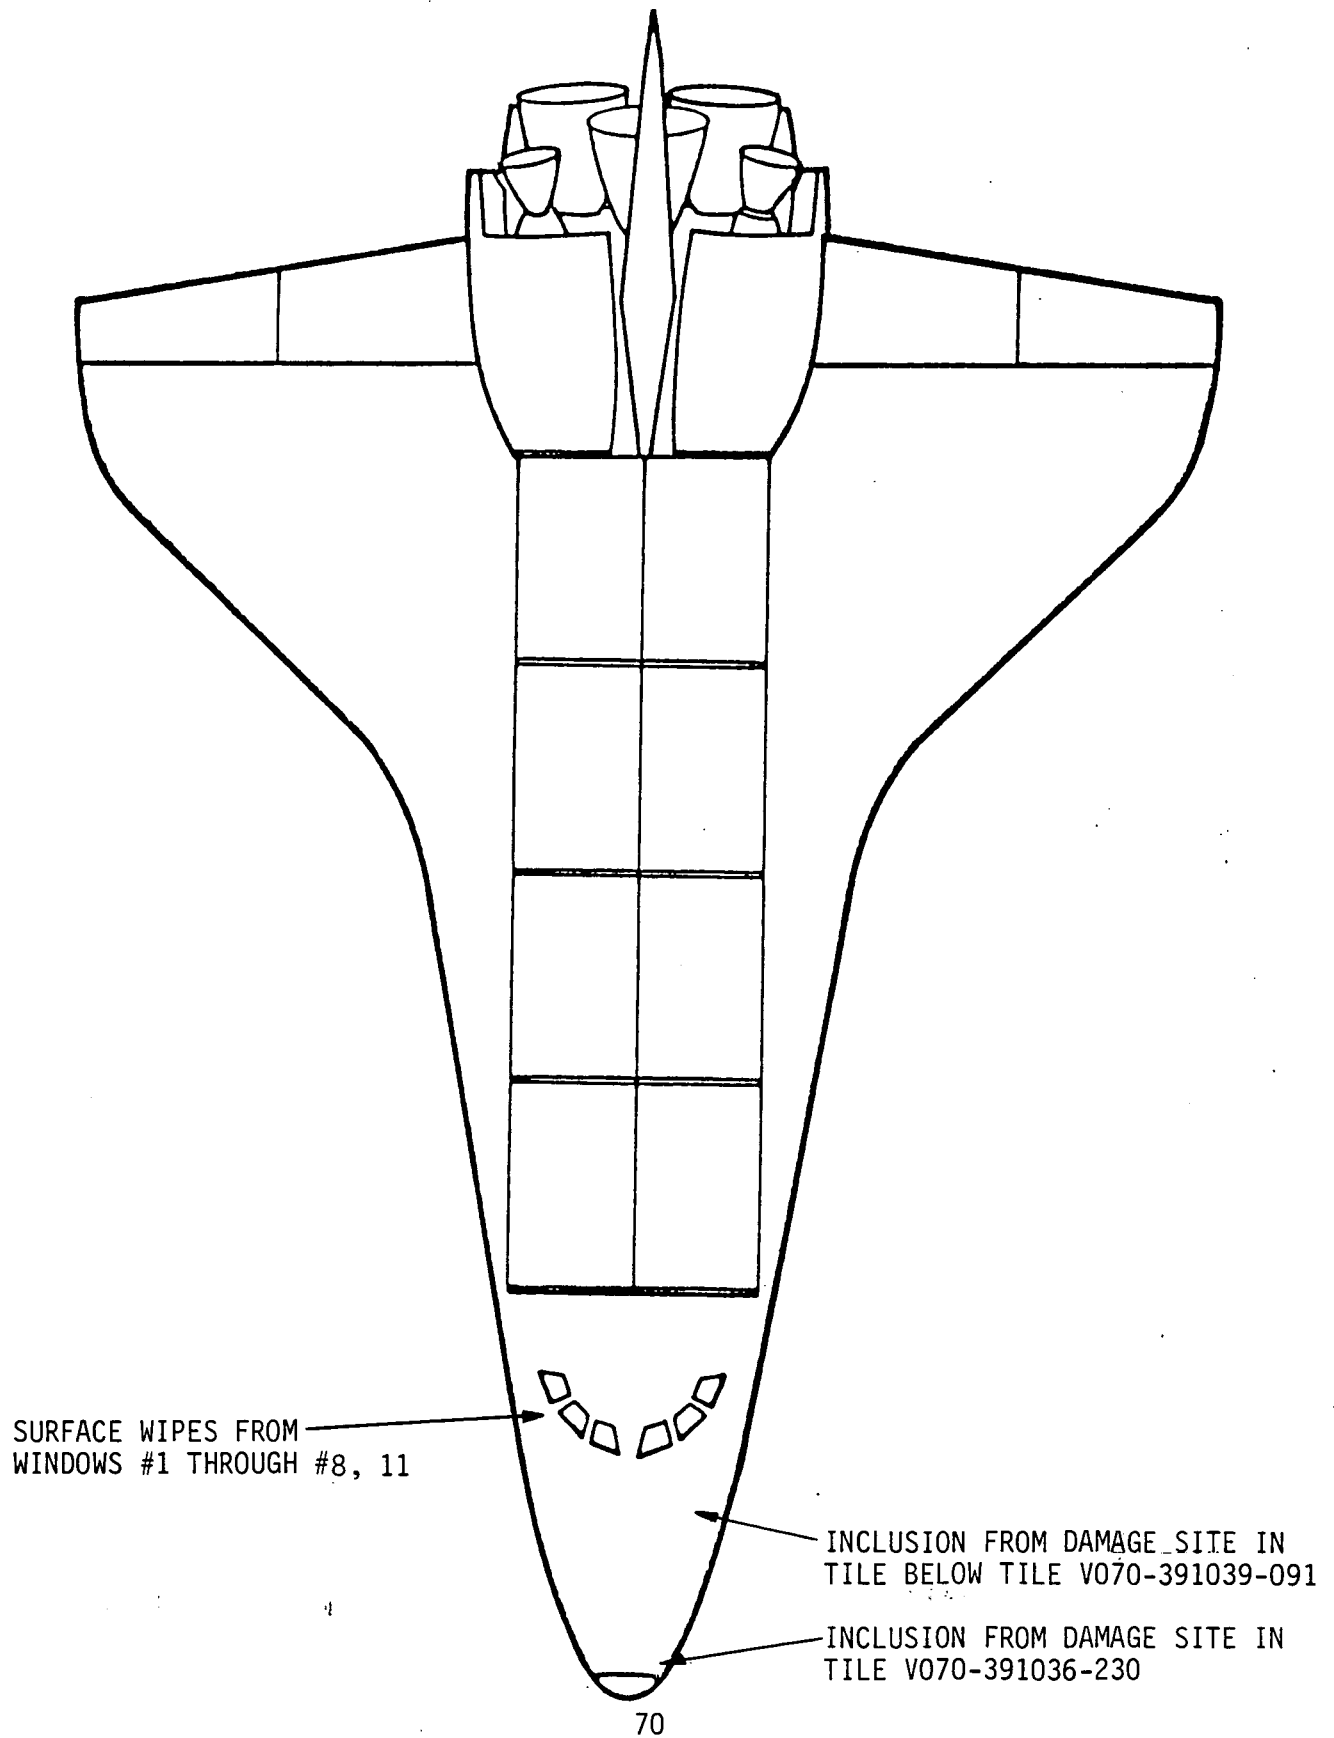
Figure 14. **CHEMICAL SAMPLE LOCATIONS**

Samples of inclusions found in two tile damage sites on the Orbiter nose were taken for laboratory analysis (reference Figure 14 for sample locations and section 8.0 for analysis results).

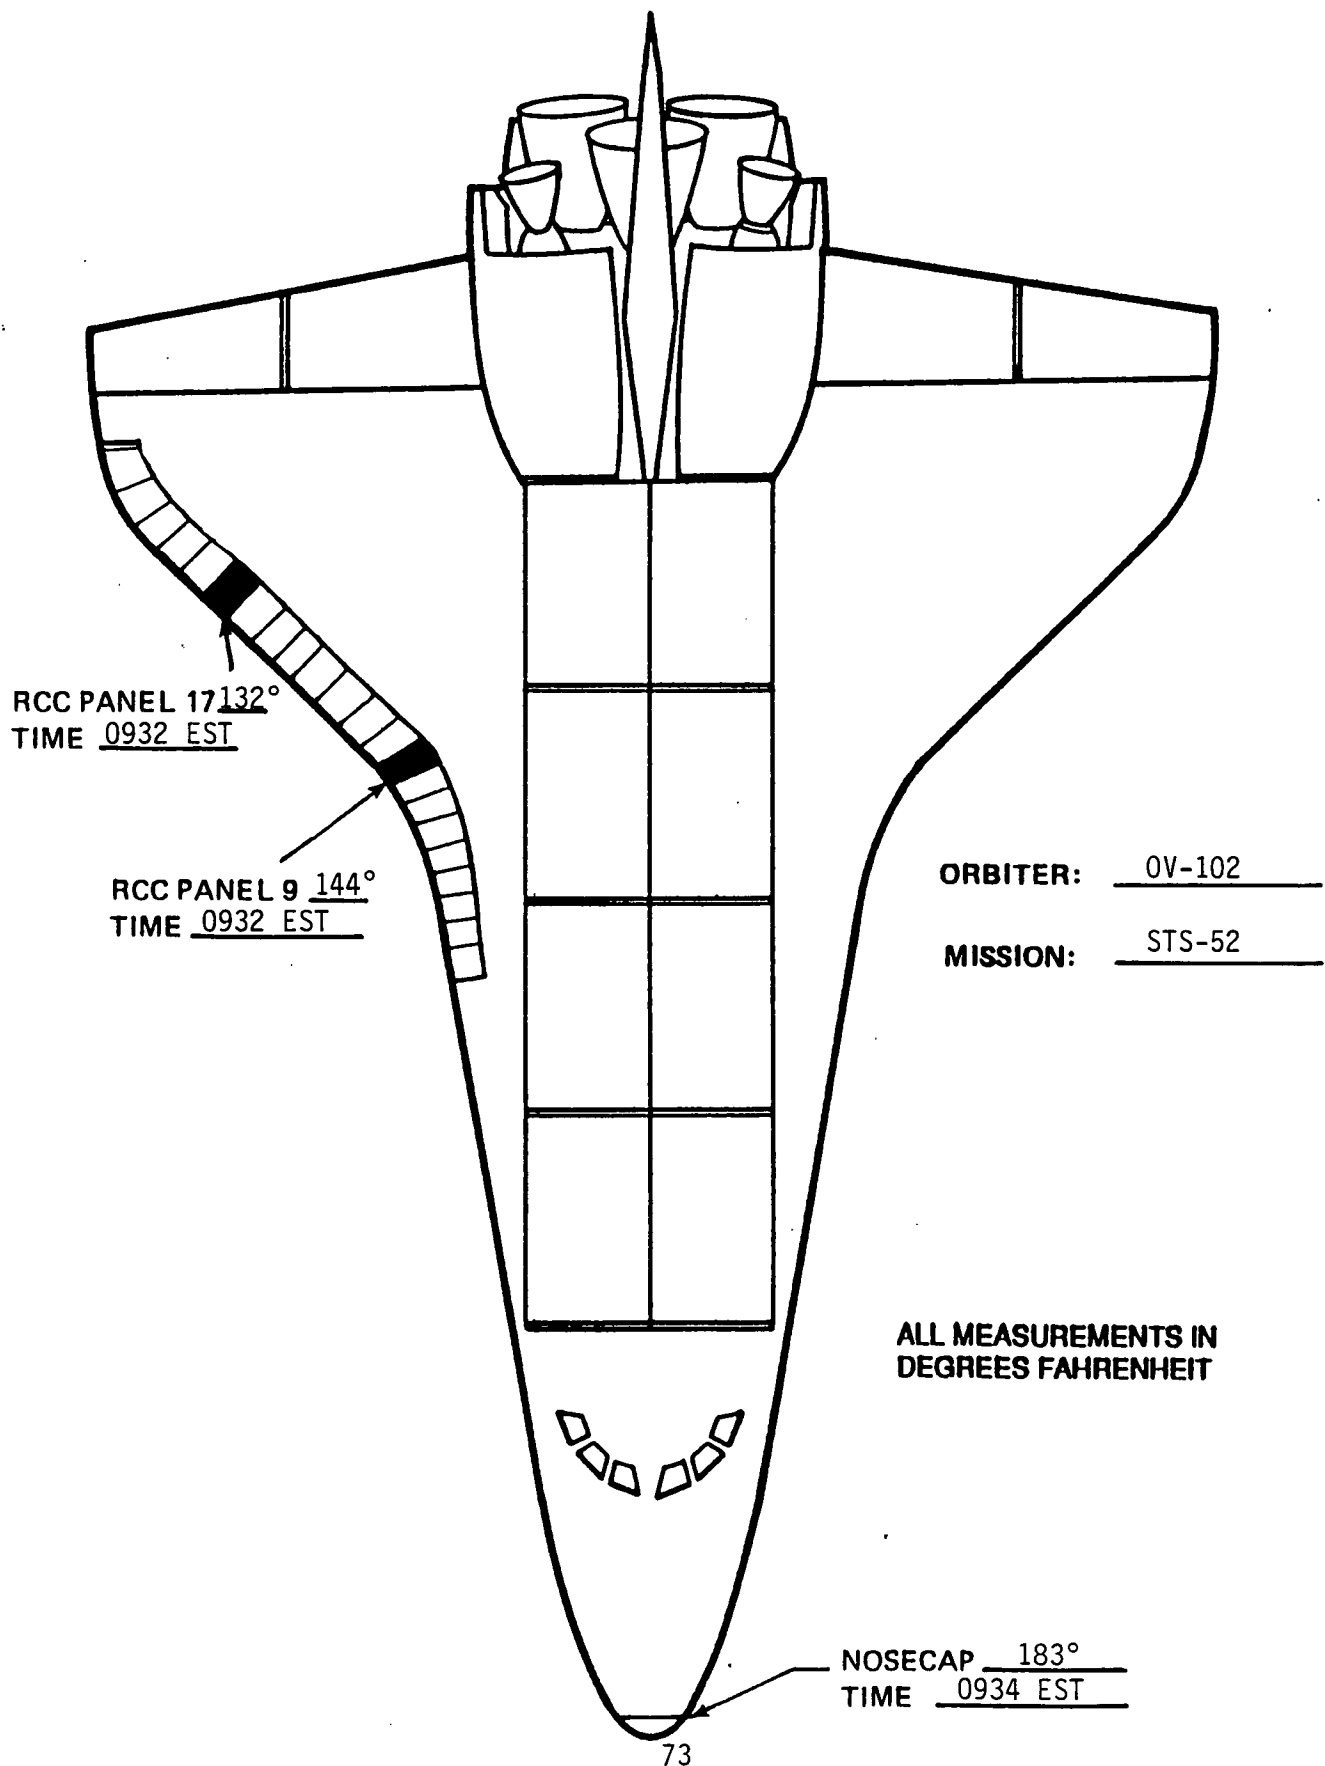
Figure 16. **STS-52 RCC TEMPERATURE MEASUREMENTS AS
RECORDED BY THE SHUTTLE THERMAL IMAGER**

A portable Shuttle Thermal Imager (STI) was used to measure the surface temperatures of three areas on the Orbiter (per OMRSD V09AJ0.095). Twenty-eight minutes after landing the Orbiter Reinforced Carbon-Carbon (RCC) nose cap was 183 degrees Fahrenheit (F). Twenty-six minutes after landing the RH wing leading edge RCC panel #9 was 144 degrees F, and panel #17 was 132 degrees F (reference Figure 16).

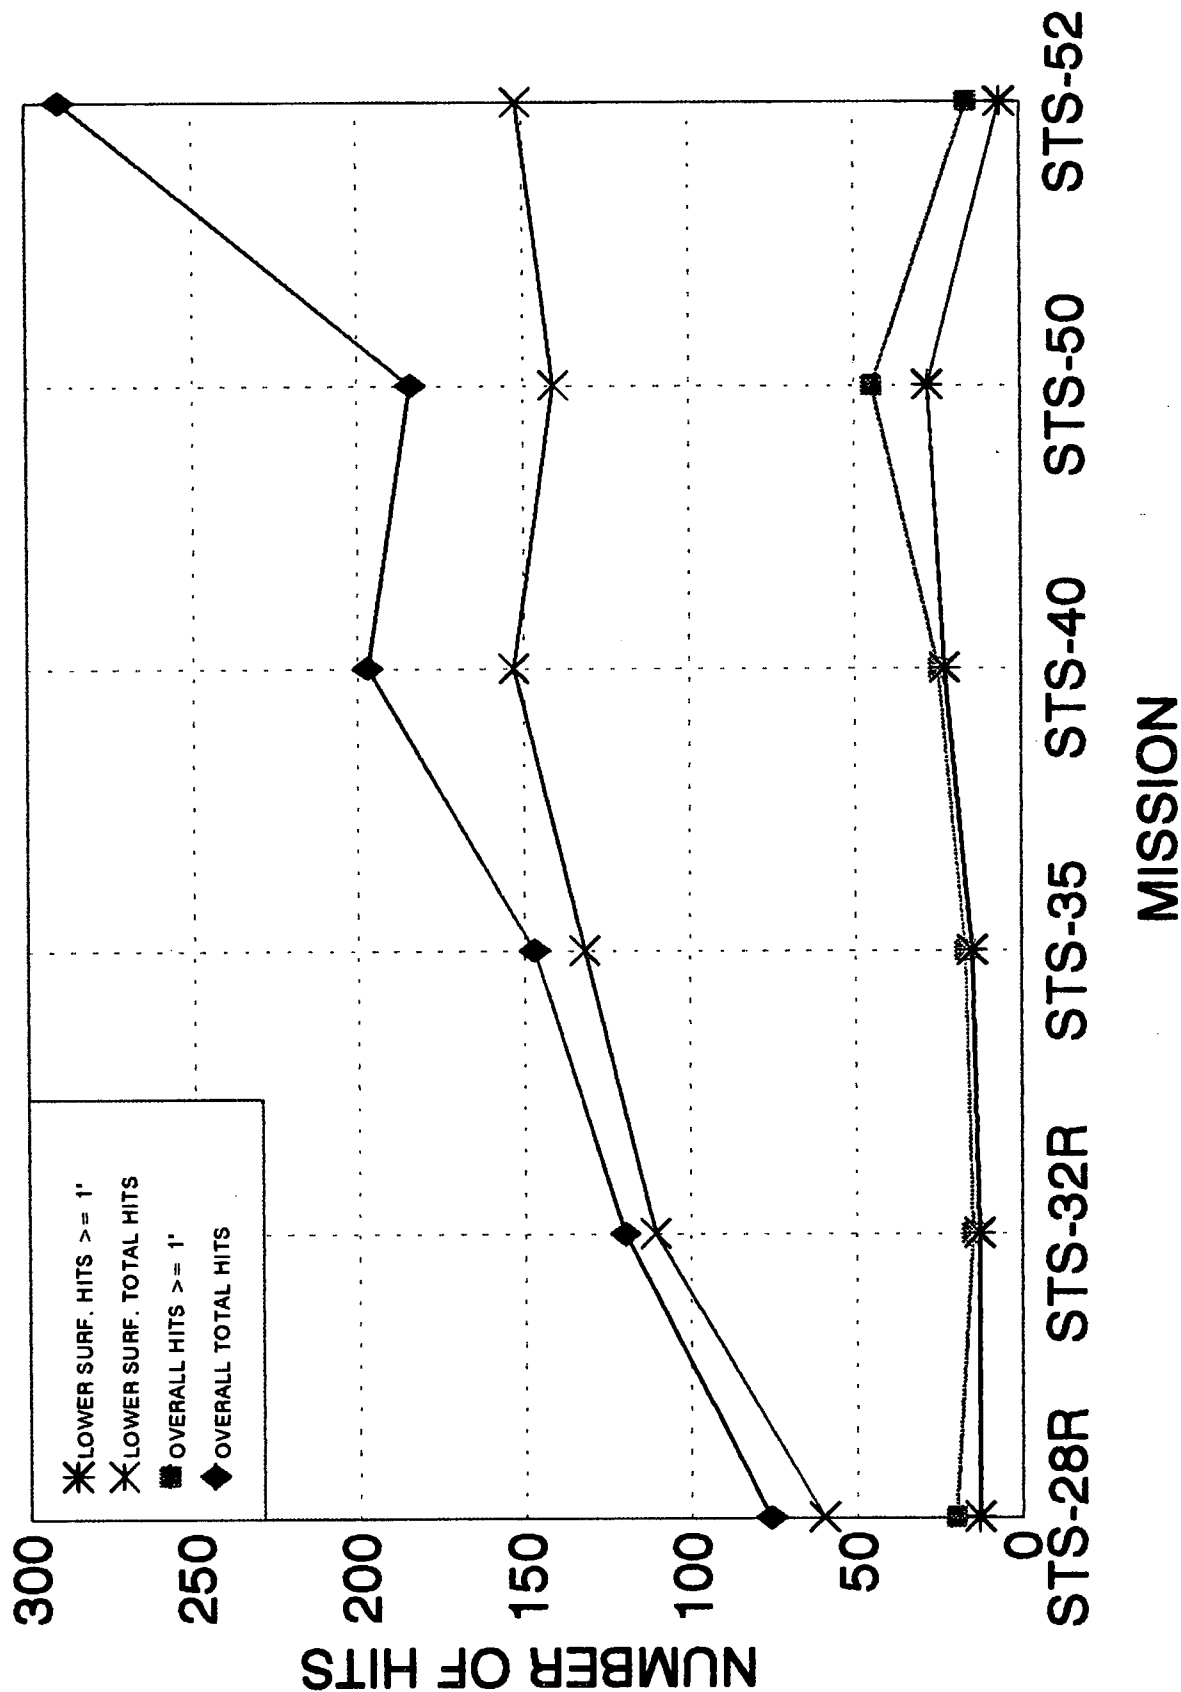
OV-102 POST LANDING DEBRIS DAMAGE

One factor that may be contributing to Orbiter debris damage is vehicle age. OV-102 has shown an increasing trend in the total number of debris hits sustained during each flight. This upward trend may be due to the effects of age on Orbiter TPS materials. Original and repaired TPS materials may become weak/loose due to the effects of thermal cycling and exposure to vibration/loading, creating potentially damaging debris. Post landing debris damage sustained by OV-102 during the last six flights is shown in Figure 20.
